# US 250 Operations Study

## Needs & Conditions Report Final

August 3, 2016

VAR-STW-STIS 2-Lane Operational Improvement Study  
PID No. 97881

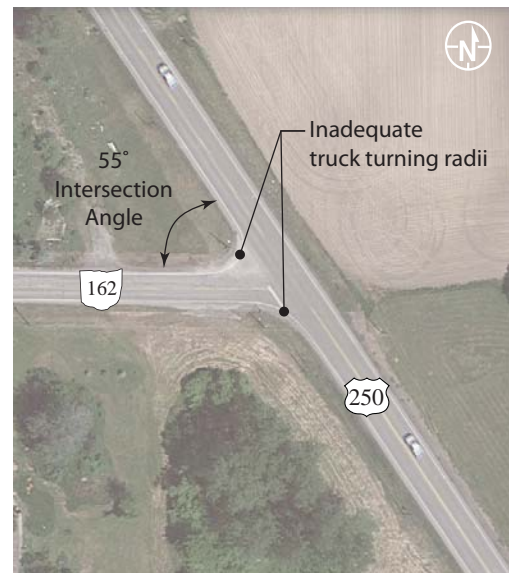
Geometric deficiencies at this location include insufficient truck turn radii and substandard intersection skew. Intersection skew does not appear to be causing crashes, but inadequate turn radii are an impediment to freight movements. Potential countermeasures should consider pavement widening to facilitate truck turning movements.

US 250 looking northwest at the intersection with SR 162 (west) just north of Fitchville.

Widening the existing intersection to improve the existing deficient turn radii, especially the eastbound US 250 to westbound SR 162 movement, would facilitate all movements for a WB-62 vehicle without oversteering.

The widening of the existing intersection to improve the deficient turn radii at this location is expected to cost approximately \$65,000.

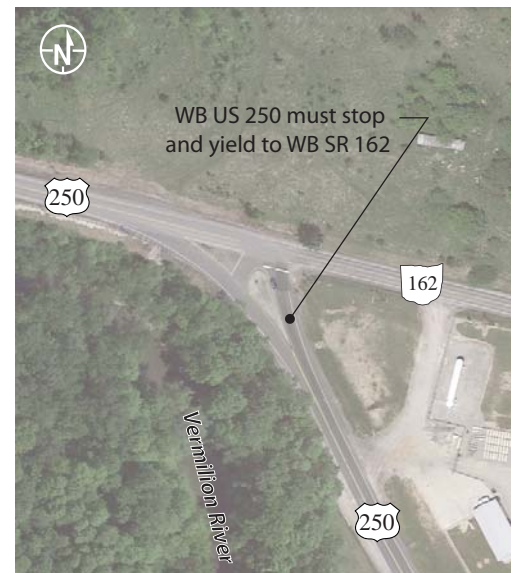
Geometric deficiencies at this location include insufficient truck turn radii and substandard intersection skew. Intersection skew does not appear to be causing crashes, but inadequate turn radii are an impediment to freight movements. Potential countermeasures should explore reconfiguring pavement striping and/or the traffic island to facilitate truck turning movements.

US 250 WB at the stop control approach to intersection with SR 162 east of Fitchville. US 250 EB and SR 162 WB approaches are free flow.

Countermeasures considered at this location included the widening/reconfiguration of the existing intersection to improve the deficient turn radii as well as realigning so that US 250 is the through movement and SR 162 intersects under stop control.

The widening/reconfiguration of the existing intersection to improve the deficient turn radius at this location is estimated to cost approximately \$130,000.

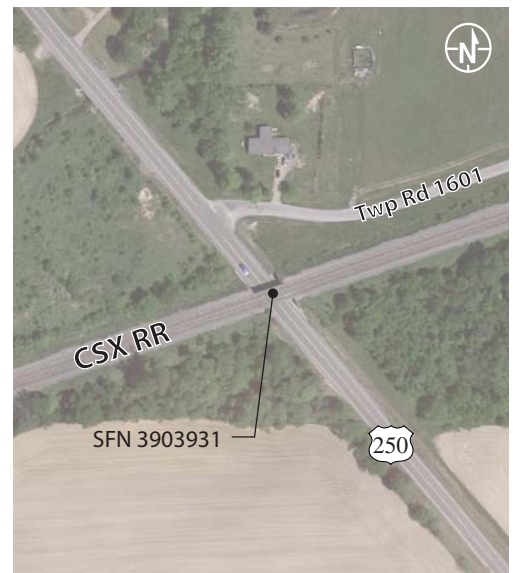
The structure has a General Appraisal of Four indicating it is in Poor Condition and Structurally Deficient. The superstructure has a Summary Rating of 4 due to the floor beams and protective coating system being in poor condition.

Deck	6
<b>Superstructure</b>	<b>4</b>
Substructure	7
Culverts	n/a
Channel	n/a
Approaches	7

The existing structure has a General Appraisal of Four (Poor) and if it deteriorates further could lead to a closure of the structure and a freight bottleneck below on US 250 during its reconstruction. The structure has a substandard vertical clearance of 14.5 ft. which poses a potential freight bottlenecks for oversize loads. Potential countermeasures should explore reconstructing the existing structure to improve its condition to a satisfactory or better level and increase vertical clearance below it to a standard 16.5 ft.

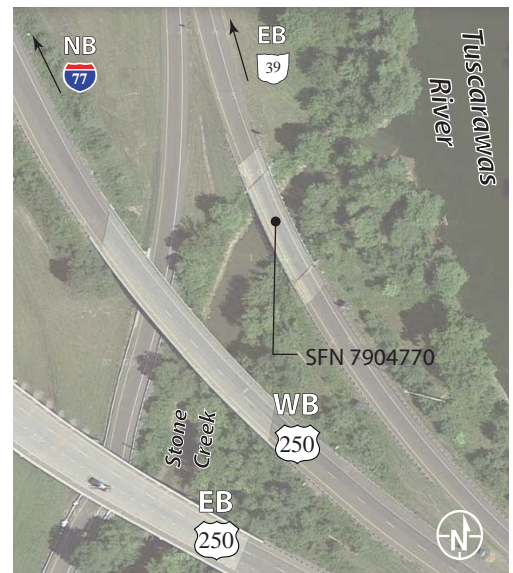
Deck	6
Superstructure	7
<b>Substructure</b>	<b>3</b>
Culverts	n/a
Channel	7
Approaches	9
<b>General Appraisal</b>	<b>3</b>

The existing structure is programmed to be replaced under PID 88945 in 2016. No further countermeasures are recommended at this location.

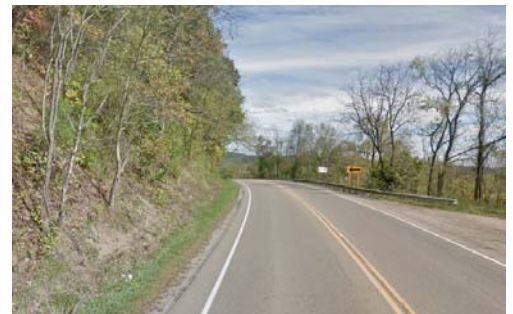
Further safety analysis is needed to determine cause of high frequency of vehicle leaving lane crashes and high crash severity (three fatal crashes). Shoulder and/or curve widening along this segment may prove cost-prohibitive due to topographic constraints. Potential low-cost countermeasures include improved warning signage and installation of centerline/shoulder rumble strips.

Looking EB headed along a horizontal curve on US 250 in Union Twp in southeastern Tuscarawas County.

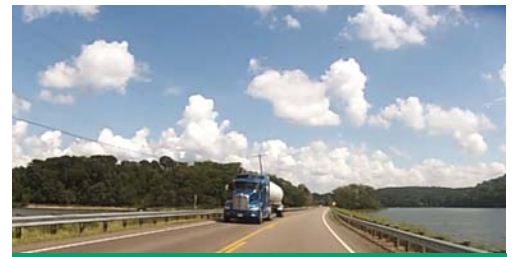
Further safety analysis is needed to determine cause of high frequency of vehicle leaving lane crashes and high crash severity (three fatal crashes). While shoulder widths are substandard along this segment, limited space is available for pavement widening due to the adjacent lake and recreational area. Potential countermeasures include the installation of edge line rumble stripes and the installation of turn lanes where space permits at major tourist destinations (i.e. the rest area, marina and boat launch).

Oil & Gas tanker traveling WB on US 250 alongside Tappan Lake in Harrison County.

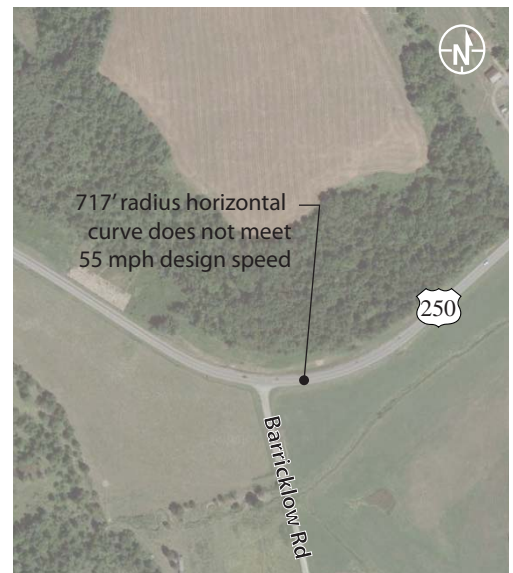
Crash severity at this location is high (two fatal crashes) and horizontal geometry is deficient for a 55 mph design speed. Potential countermeasures include additional warning signage in advance of and along this curve, the installation of rumble strips, and curve widening on this inside of this curve.

Looking EB along US 250 at sharp horizontal curve just west of the Harrison County Home.

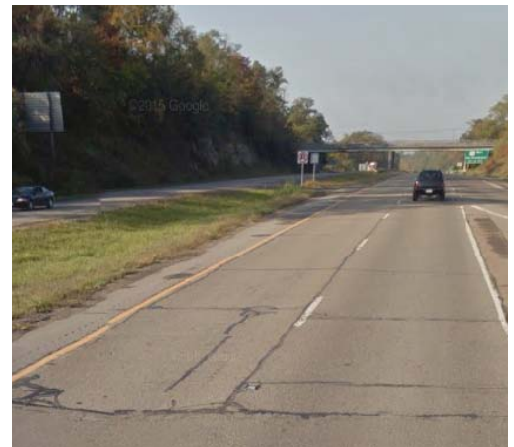
The pavement along this four-lane freeway segment has a PCR of 68 (Fair Condition). Potential countermeasures include full-depth pavement reconstruction.

Traverse and longitudinal cracking is present in pavement looking west along US 250 / US 22 (Cadiz Bypass) west of US 250 / SR 9 interchange.

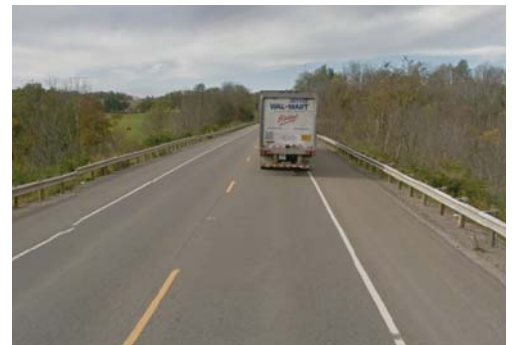
Further safety analysis is needed to determine cause of high frequency of vehicle leaving lane crashes and high crash severity (three fatal crashes). Potential countermeasures include installation of centerline and shoulder rumble strips.

Looking westbound along the 2-lane segment of US 22 in Harrison County.
