# US 250 Operations Study

## Needs & Conditions Report Final

August 3, 2016

VAR-STW-STIS 2-Lane Operational Improvement Study  
PID No. 97881

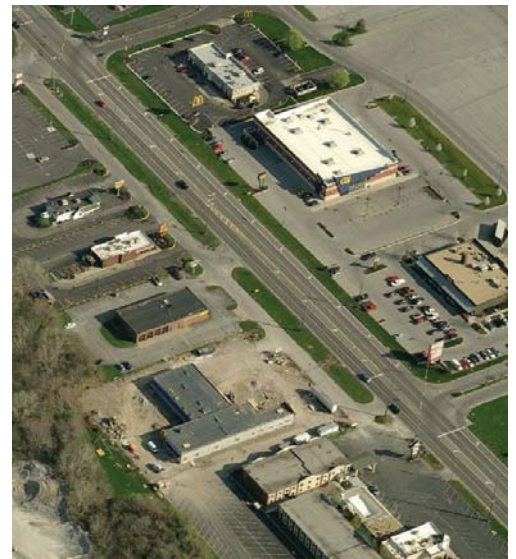
The segment of US 250 between US 6 and SR 2 is a four/five-lane urban arterial in highly commercialized area that serves as the gateway to Cedar Point tourist traffic during from April through October, as well as servicing heavy retail traffic during the holiday shopping season in November and December.

Aerial view of the 5-lane segment of US 250 in a highly commercialized area in Perkins Twp just south of Sandusky and Cedar Point.

A programmed ODOT TRAC project (PID 88407) will upgrade signals and signing, incorporate access management, and add turn lanes where needed to address noted safety and congestion issues. No further countermeasures are recommended.

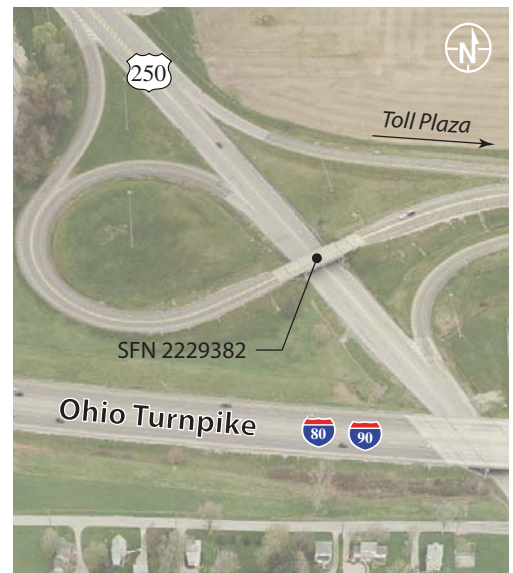
The structure has a General Appraisal of Six indicating it is in Satisfactory Condition. The Load Rating for this structure is 140% of the Ohio Legal Load. Structures with a Load Rating of less than 150% of the Ohio Legal Limit potentially restrict the freight flow of Permit Loads along the corridor.

The existing structure has a Load Rating of 140% of the Ohio Legal Load and a substandard vertical clearance of 14.7 ft., both of which pose potential freight bottlenecks for oversize/overweight loads. Potential countermeasures should explore reconstructing the existing structure to improve its Load Rating to 150% of the Ohio Legal Limit and increase vertical clearance to a standard 16.5 ft.

Deck	7
Superstructure	7
Substructure	6
Culverts	n/a
Channel	n/a
<b>Approaches</b>	<b>4</b>
General Appraisal	6

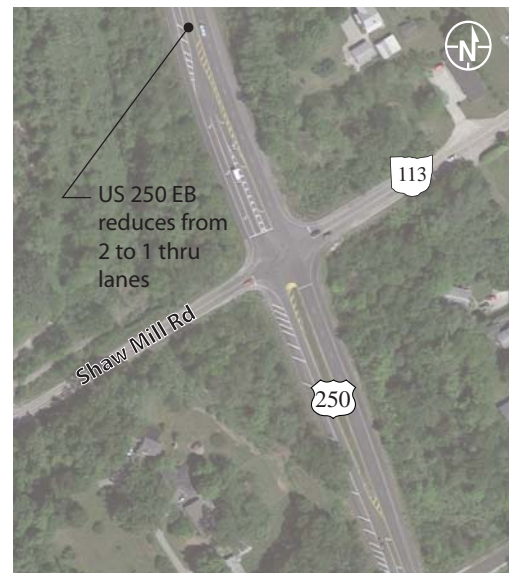
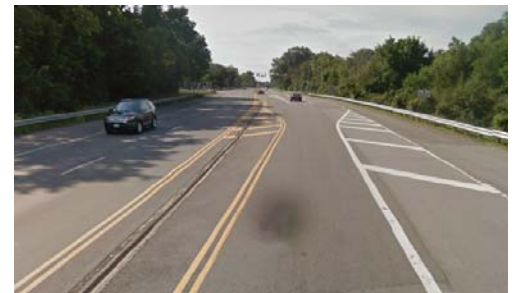
The signalized intersection of US 250 and SR 113 at the edge of the Village of Milan in Erie County is the bottleneck where US 250 moving east transitions from five lanes to two lanes.

The frequency of crashes at this location indicate a safety issue may be present. Potential countermeasures include reviewing yellow/all-red signal timings.

Looking south along US 250 (EB) approaching SR 113 (east) where US 250 drops from 2 to 1 thru lanes outside the Village of Milan.

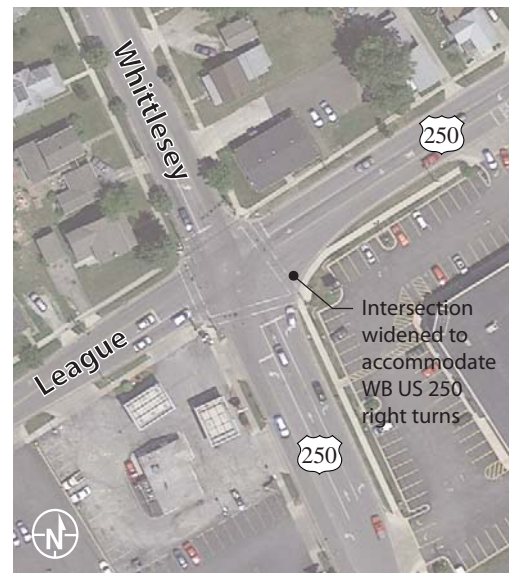
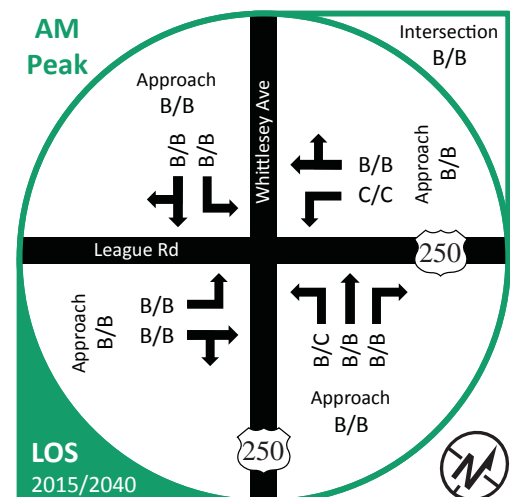
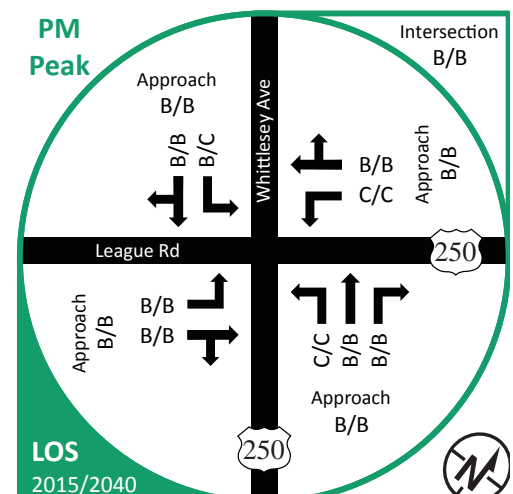
Crash analysis shows 30 crashes observed at this intersection during a three-year period (2012 to 2014) with the majority being either rear end (11 crashes) or angle (nine crashes). Normally rear end crashes may be attributed to congestion at an intersection, while angle crashes lack of gaps in opposing traffic for turning vehicles, but traffic analysis does not show any movements operating at unacceptable levels. Four crashes involved trucks, with three of those crashes involving trucks making a westbound left turn movement. AutoTurn analysis shows adequate truck turn radii for all movements.

The frequency of crashes at this location indicate a safety issue may be present. Potential countermeasures include reviewing yellow / all-red signal timings.

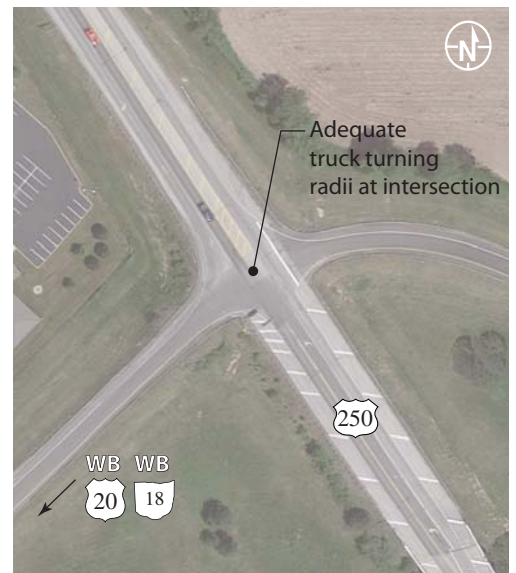
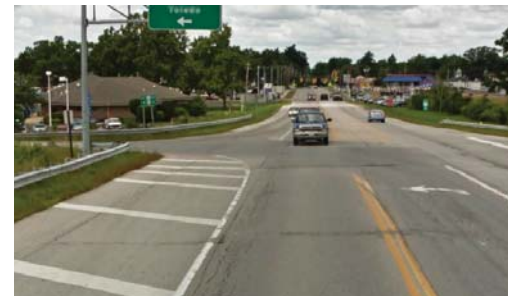
Crash analysis shows only one crash observed at this intersection during a three-year period (2012 to 2014) so no further safety analysis is required. AutoTurn analysis shows an adequate turn radius for westbound trucks turning left.

The low crash frequency at this location indicates there are no safety issues and adequate turn radii exist for truck movements. No further countermeasures are recommended at this location.

US 250 looking northwest at intersection with US 20/SR 18 (Norwalk bypass) WB Ramps.

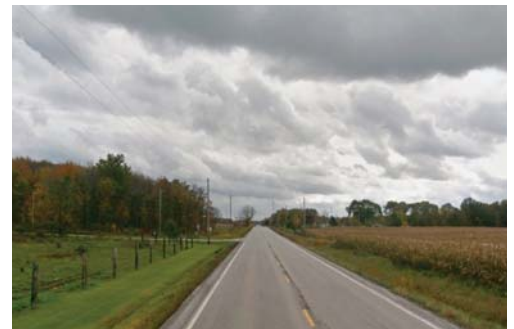
Crash analysis shows 134 crashes observed along this segment during a three-year period (2012 to 2014). There were only two left of center - sideswipe meeting crashes indicating centerline rumble strips are working well. Run off the road right fixed object crash frequency was fairly high with 36 crashes, which may correlate with substandard three ft. shoulders present along this segment as the L&D standard is eight ft. for an arterial. This segment also exhibited a high frequency of animal crashes.

The high frequency of run off the road right fixed object crashes despite the presence of shoulder rumble strips indicates that the substandard three ft. shoulders along this segment are a safety issue. Potential countermeasures include shoulder widening to meet L&D standards (eight ft.).

Looking SW along the straight, flat stretch of US 250 traversing farmland in rural Huron County.

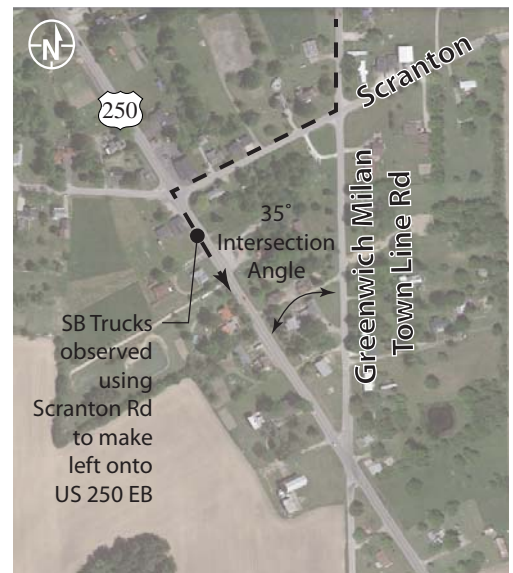
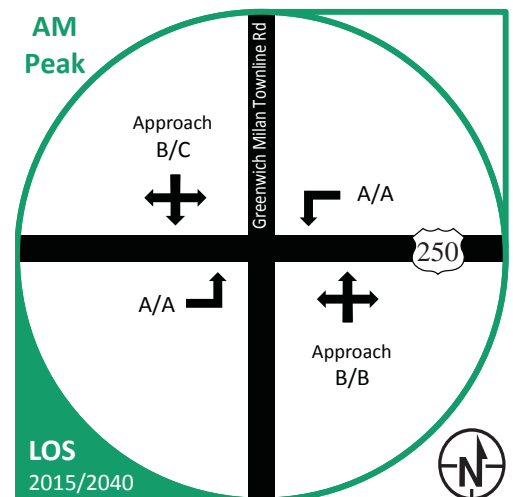
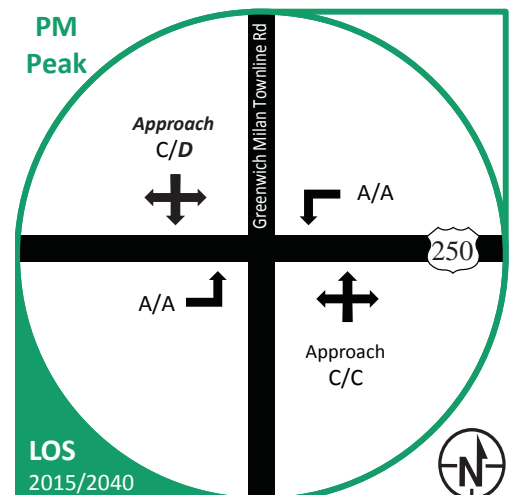
Crash analysis shows zero crashes observed at this intersection during a three-year period (2012 to 2014) so no further safety analysis is required. A severe intersection skew angle (35 degrees) impairs sight distance at the stop control approaches, but that intersection skew does not appear to be contributing to crashes.

The existing intersection currently operates at an acceptable LOS, but degrades to a LOS D on the southbound CR 51 approach in the 2040 PM peak hour. The existing intersection angle (35 degrees) does not meet the L&D standard of 70 degrees, but this geometric deficiency does not appear to be causing crashes. Potential countermeasures to improve operation on the southbound approach are limited as improvements would increase overall delays on the much higher freight volume US 250 approaches.

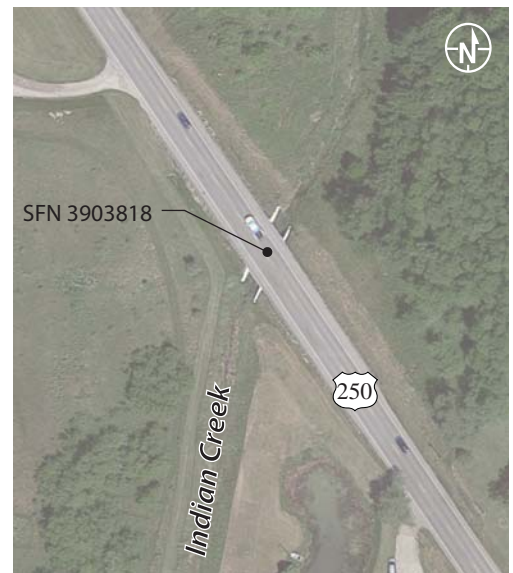
The structure has a General Appraisal of Six indicating it is in Satisfactory Condition. The Load Rating for this structure is 145% of the Ohio Legal Load. Structures with a Load Rating of less than 150% of the Ohio Legal Limit potentially restrict the freight flow of Permit Loads along the corridor.

The existing structure has a Load Rating of 145% of the Ohio Legal Load and a substandard lateral clearance of seven ft., both of which pose potential freight bottlenecks for oversize/overweight loads. Potential countermeasures should explore reconstructing the existing structure to improve its Load Rating to 150% of the Ohio Legal Limit and increase its lateral clearance to a standard eight ft.

Deck	6
Superstructure	6
Substructure	7
Culverts	n/a
Channel	6
Approaches	7
<b>General Appraisal</b>	<b>6</b>

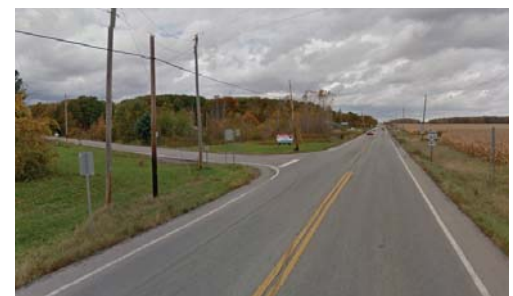
Geometric deficiencies at this location include insufficient truck turn radii and substandard intersection skew. Intersection skew does not appear to be causing crashes, but inadequate turn radii are an impediment to freight movements. Potential countermeasures should consider pavement widening to facilitate truck turning movements.

US 250 looking northwest at the intersection with SR 162 (west) just north of Fitchville.

Widening the existing intersection to improve the existing deficient turn radii, especially the eastbound US 250 to westbound SR 162 movement, would facilitate all movements for a WB-62 vehicle without oversteering.

The widening of the existing intersection to improve the deficient turn radii at this location is expected to cost approximately \$65,000.

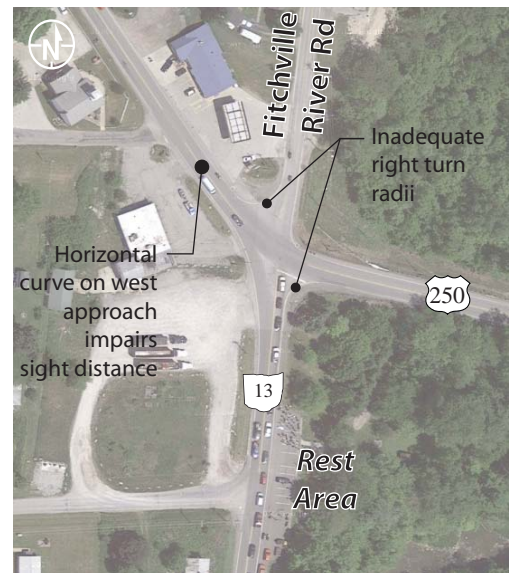
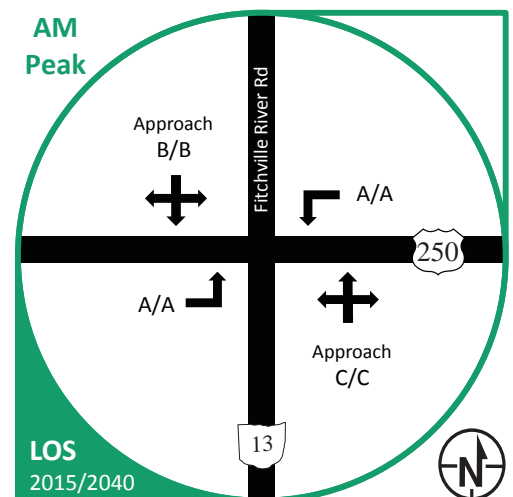
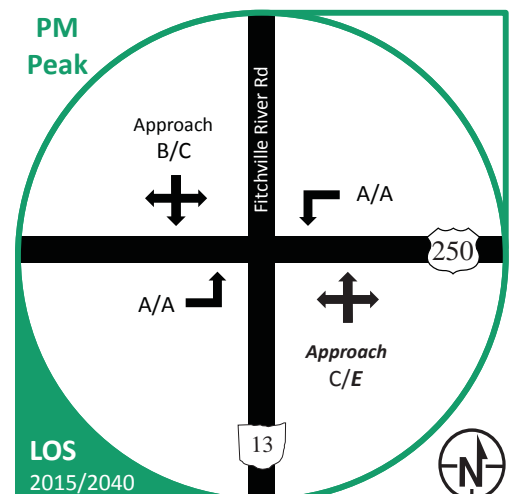
Crash analysis shows only six crashes observed at this intersection during a three-year period (2012 to 2014). Field inspection shows that the northwest and southeast corners are traveled off road to complete tight southbound/northbound right turn movements. The intersection skew west of the intersection impairs sight distance southbound looking east.

The existing intersection currently operates at an acceptable LOS, but degrades to a LOS E on the northbound SR 13 approach in the 2040 PM peak hour. The existing intersection angle west of the intersection does not meet the L&D standard of 70 degrees, but this geometric deficiency does not appear to be causing crashes. Potential countermeasures to improve operation on the northbound approach include installation of traffic signal which is likely warranted.

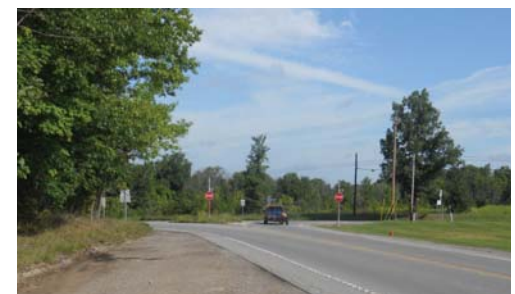
Geometric deficiencies at this location include insufficient truck turn radii and substandard intersection skew. Intersection skew does not appear to be causing crashes, but inadequate turn radii are an impediment to freight movements. Potential countermeasures should explore reconfiguring pavement striping and/or the traffic island to facilitate truck turning movements.

US 250 WB at the stop control approach to intersection with SR 162 east of Fitchville. US 250 EB and SR 162 WB approaches are free flow.

Countermeasures considered at this location included the widening/reconfiguration of the existing intersection to improve the deficient turn radii as well as realigning so that US 250 is the through movement and SR 162 intersects under stop control.

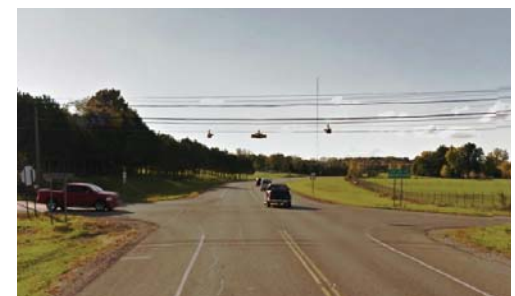
Crash analysis shows nine angle crashes observed at this intersection during a three-year period (2012 to 2014). Crashes occurred largely on weekends during the midday hours. Possible causes include intersection sight distance restrictions, the inability of drivers on Cleveland Avenue to judge gaps in US 250 traffic - likely due to the sweeping curve on US 250 to the west, and driver impatience. While not a consistently heavy movement, eastbound traffic waiting to turn left onto US 42 traffic does limit sight distance for vehicles on northbound Cleveland Avenue.

Safety analysis shows a high frequency of angle crashes at this intersection. Potential countermeasures include upgrading intersection signage to improve intersection awareness as well as reviewing signal warrants and analyzing alternative intersection control.

Looking west along US 250 at the intersection with Cleveland Ave near the ODOT District 3 office.

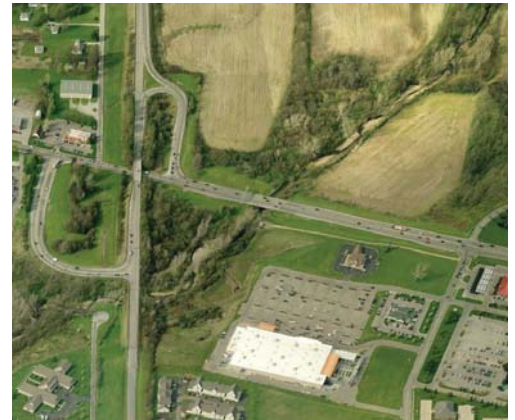
Crash analysis shows a high concentration of crashes (92) observed along this 0.7-mile segment during a three-year period (2012 to 2014) with the majority being rear end (51). There were 30 injury crashes and only three crashes involved trucks.

Aerial view of the previous condition at US 250 and US 42 in the City of Ashland.

An underway project (PID 88739) will alleviate congestion and enhance safety by removing the US 42 bridge, lowering US 42 and creating a signalized intersection at East Main Street. The area will be widened to provide additional through and turning lanes on the intersection approaches. No further countermeasures are recommended at this location.

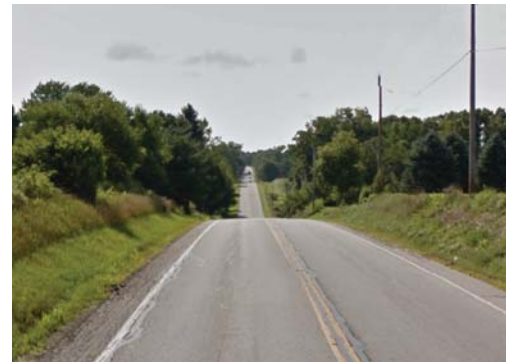
Safety analysis shows a high frequency of vehicle leaving lane crashes along this segment, likely correlating to deficient (three ft.) shoulder widths. Potential low-cost countermeasures include installation of edge line rumble stripes.

The rolling terrain along US 250 looking SE just east of Twp Rd 1400 in Perry Twp, Ashland County.

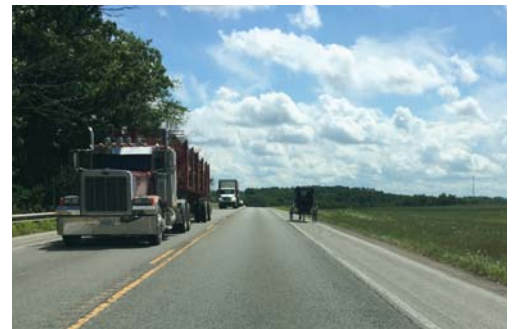
The frequency of crashes along this segment indicate a safety issue may be present. Potential countermeasures include the installation of edge line rumble stripes.

Looking SE along US 250 in Amish Country where horse-drawn buggies utilize 6' shoulders directly adjacent to freight traffic. Rumble stripes located on the centerline.

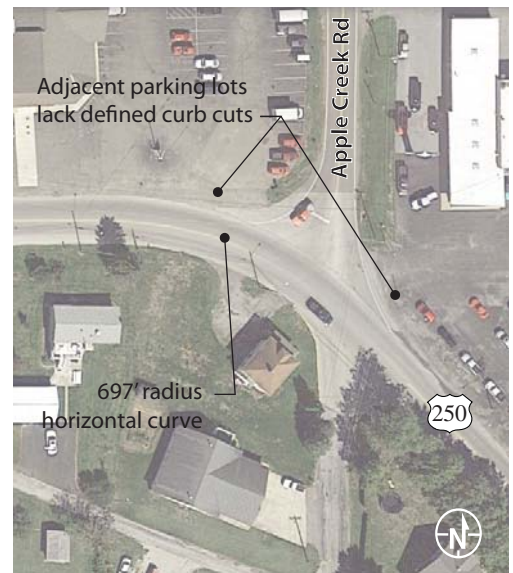
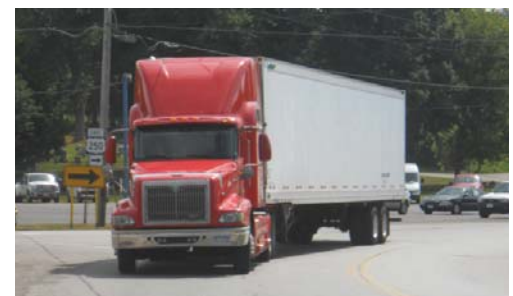
Crash analysis shows only one crash observed at this intersection during a three-year period (2012 to 2014) that was alcohol-related. The existing horizontal curve radius (697 ft.) meets L&D standards for a 35 mph design speed assuming the curve is properly superelevated.

Safety analysis does not reveal a crash problem at this location due to a low frequency of observed crashes. However, a potential low-cost countermeasure to reduce expected crashes would be to upgrade advance warning signage.

Truck headed WB along US 250 around horizontal curve at intersection with Apple Creek Rd (CR 44) at west edge of the Village of Apple Creek.

Although few crashes were recorded in the three year crash history, a proactive approach to upgrade the existing curve warning signage would improve awareness of this abruptly sharp horizontal curve. Upgrades to existing signage include relocating the advanced curve warning signage in accordance with OMUTCD guidelines and replacing the single curve warning signs with dual curve warning signs. In addition, the large arrow signs on the curve should be replaced with larger “oversize” arrow signs.

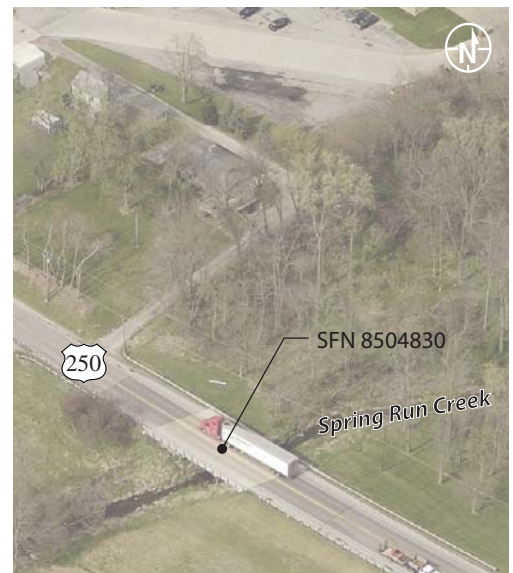
The structure has a General Appraisal of Five indicating it is in Fair Condition. The Load Rating for this structure is 145% of the Ohio Legal Load. Structures with a Load Rating of less than 150% of the Ohio Legal Limit potentially restrict the freight flow of Permit Loads along the corridor.

The existing structure has a Load Rating of 140% of the Ohio Legal Load which poses potential freight bottlenecks for overweight loads. Potential countermeasures should explore reconstructing the existing structure to improve its Load Rating to 150% of the Ohio Legal Limit.

Deck	6
Superstructure	6
Substructure	5
Culverts	n/a
Channel	7
Approaches	7
<b>General Appraisal</b>	<b>5</b>

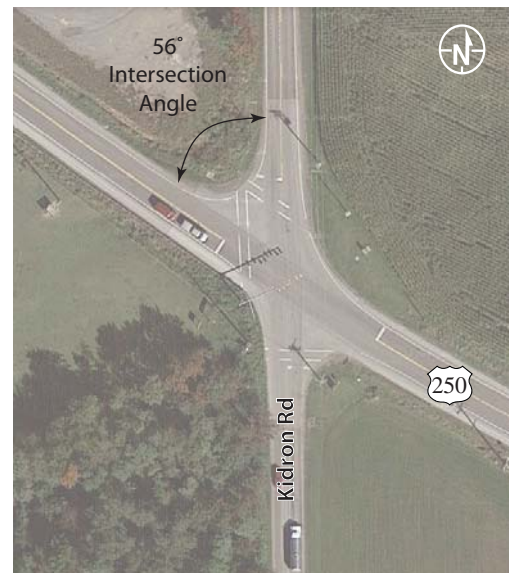
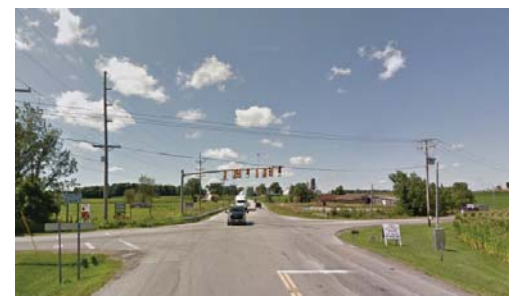
The existing intersection angle (56°) is deficient as L&D minimum for a signalized intersection is 60°. In general, this signalized intersection is contrary to driver expectation along this high-speed rural segment of corridor which may account for six of the seven crashes.

A safety analysis of this intersection indicates crash patterns can be attributed to this signalized intersection being contrary to driver expectation. Potential countermeasures may include additional advance warning signage for the traffic signal.

Looking NW along US 250 at the skewed intersection with Kidron Rd (CR 52) in Paint Twp, Wayne County.

Upgrading the existing traffic signal configuration with span wire or new mast arms and signal backplates would potentially reduce driver confusion caused by eight signal heads closely spaced on one mast arm.

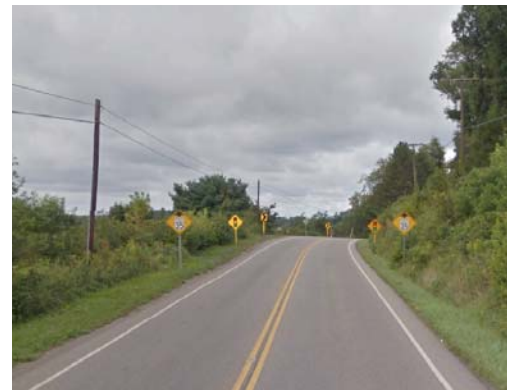
Crash analysis shows 53 crashes observed along this 5.1-mile segment during a three-year period (2012 to 2014) with the majority being either fixed object (21) or rear end (12).

The crash analysis does not indicate a crash pattern heading westbound into Wilmot around a horizontal curve and vertical curve as anticipated. Only one Amish Buggy crash was observed along this segment. 43% of crashes occurred in dark conditions indicative of possible poor pavement marking and/or signage reflectivity.

This segment has a high frequency of fixed object crashes, substandard shoulder widths, and possible sight distance issues. Shoulder widening along this segment may prove cost-prohibitive due to topographic constraints. Potential low-cost countermeasures include improved warning signage, installation of edge line rumble stripes (where shoulder width is sufficient, positive drainage is present or can be achieved, and they will not affect buggy traffic) and provided flexible delineator posts where rumble stripes are not feasible.

Looking WB along US 250 approaching a horizontal curve at the east edge of the Village of Wilmot.

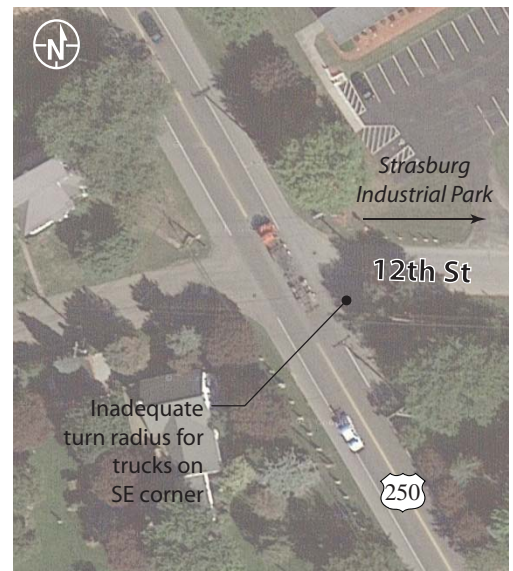
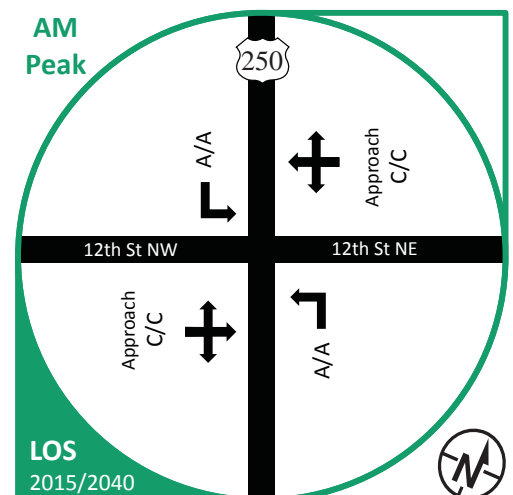
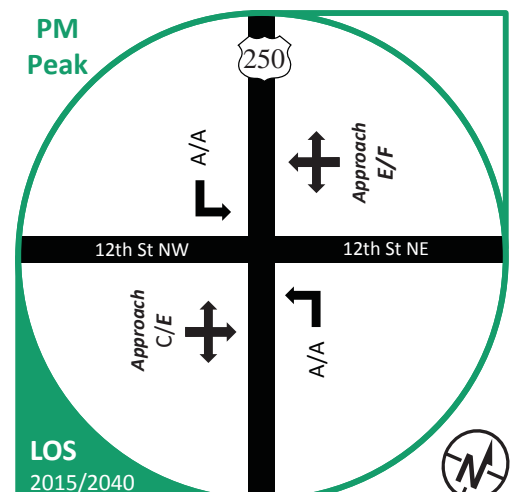
### INTERSECTION: US 250 & 12TH STREET TUS-250-3.32

Crash analysis shows only one crash observed at this intersection during a three-year period (2012 to 2014). AutoTurn analysis shows inadequate turn radii for trucks turning to and from the east 12th Street approach and Schlumberger facility.

The existing intersection operates at unacceptable LOS in the PM peak hour, but does not meet a signal warrant. Potential countermeasures to improve operation on the southbound approach are limited as improvements would degrade operation on the much higher volume US 250 approaches so rerouting local freight traffic to another access point along US 250 should be explored. If freight traffic cannot be rerouted, potential countermeasures at 12th Street should explore pavement widening to facilitate truck turning movements.

Widening the existing intersection to improve the existing deficient turn radii, particularly at the southeast corner, would facilitate all movements to and from Strasburg Industrial Park for a WB-62 truck without oversteering.

The widening of the existing intersection to improve the deficient turn radii at this location is expected to cost approximately \$60,000, which includes right way costs.

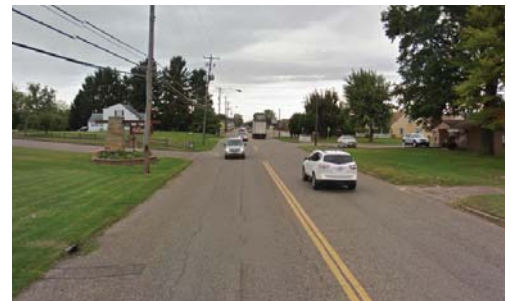
Looking southeast along US 250 in the Village of Strasburg where potential exists to restripe the existing pavement section as 3-lanes with a 2-way left-turn lane.

This segment of the corridor experienced a high frequency of rear end crashes due to congestion and access issues. Potential countermeasures include restriping the existing 40-ft. pavement section from two lanes to three lanes with a two-way left turn lane to avoid left turns blocking through traffic as there are numerous side streets and commercial drives present in the Village of Strasburg.

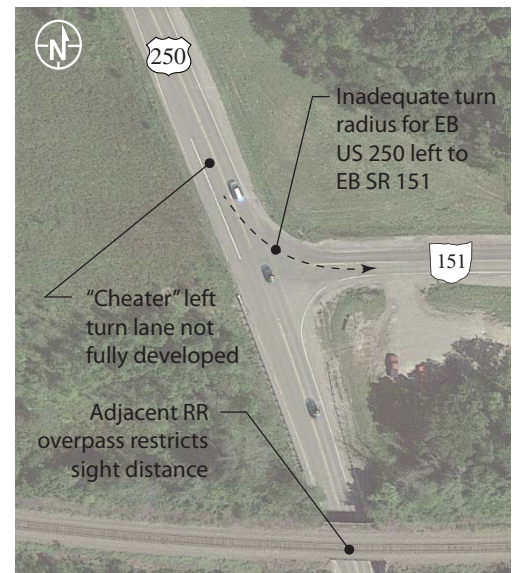
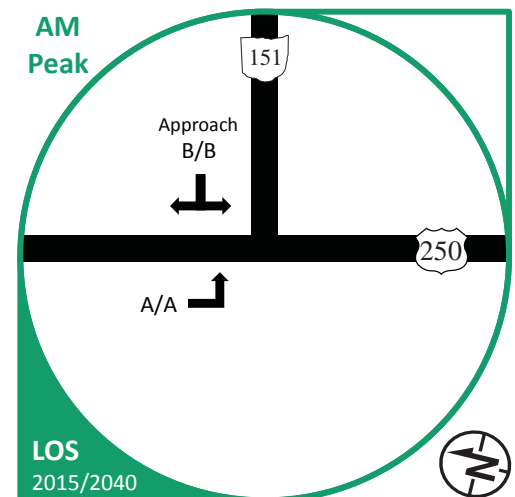
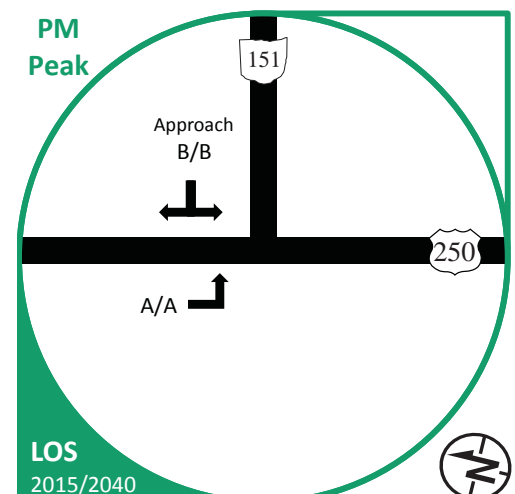
### INTERSECTION: US 250 & SR 151 HAS-250-0.77

Crash analysis shows nine crashes observed at this intersection during a three-year period (2012 to 2014) with three rear end crashes and one fatal. AutoTurn analysis shows inadequate turn radii for trucks with eastbound lefts turns overlapping the SR 151 westbound lane and westbound right turns tracking off the pavement. Sight distance is approximately 230 ft. for right turns from SR 151.

The existing intersection operates at an acceptable LOS, but geometric deficiencies exist including insufficient truck turn radii and sight distance issues. Potential countermeasures should explore moving stop bars/pavement widening to facilitate truck turning movements, improving warning signage to mitigate sight distance issues, and fully developing the existing “cheater” left turn lane along US 250 eastbound.

Widening the existing intersection to improve the existing deficient turn radii, particularly at the southeast corner, would facilitate movements to and from SR 151, frequently traveled by oil and gas exploration freight, for a WB-62 truck without oversteering.

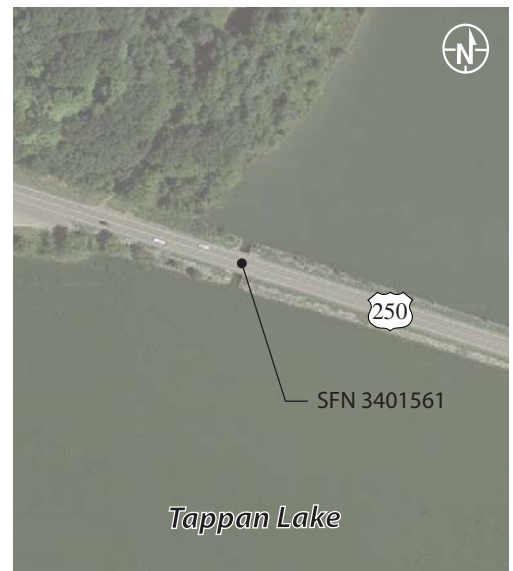
### BRIDGE: US 250 OVER TAPPAN LAKE HAS-250-3.70 (SFN 3401561)

The structure has a General Appraisal of Six indicating it is in Satisfactory Condition. The Load Rating for this structure is 145% of the Ohio Legal Load. Structures with a Load Rating of less than 150% of the Ohio Legal Limit potentially restrict the freight flow of Permit Loads along the corridor.

The existing structure has a Load Rating of 145% of the Ohio Legal Load and a substandard lateral clearance of 7.25 ft., both of which pose potential freight bottlenecks for oversize/overweight loads. Potential countermeasures should explore rehabilitating/reconstructing the existing structure to improve its Load Rating to 150% of the Ohio Legal Limit and increasing lateral clearance to a standard eight-ft.

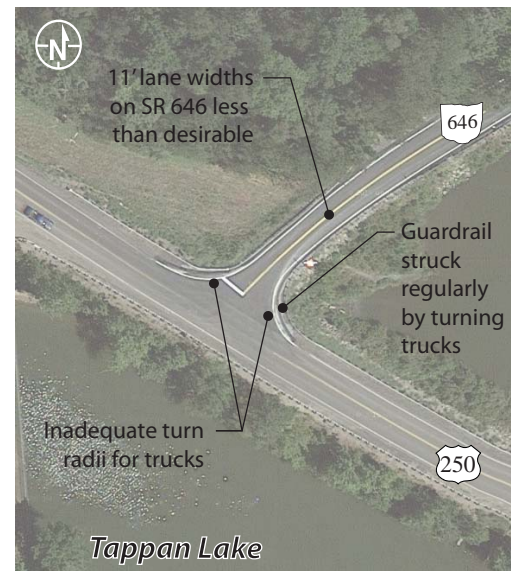
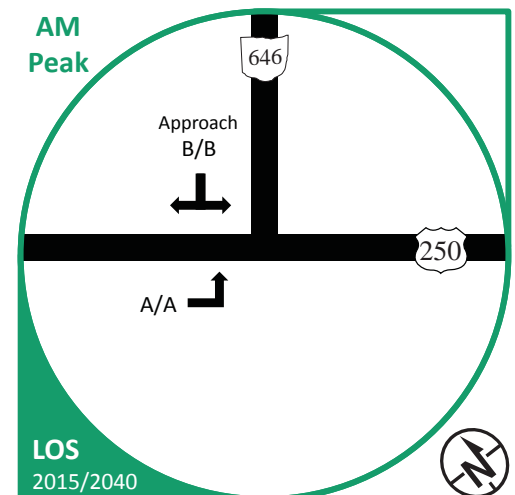
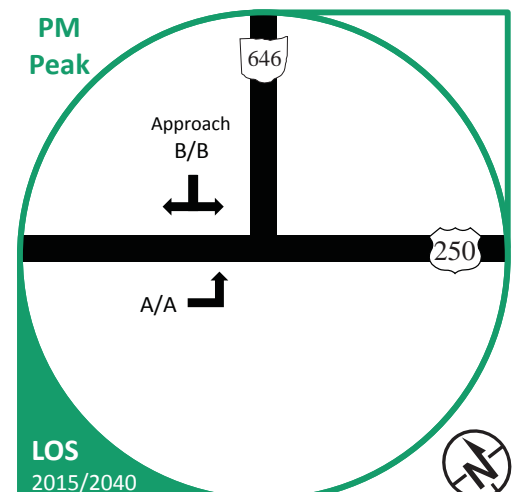
### INTERSECTION: US 250 & SR 646 HAS-250-9.28

Crash analysis shows six crashes observed at this intersection during a three-year period (2012 to 2014) with crash severity being high (two fatal and one injury). Sight distance from SR 646 at this location is deficient. The guardrail at the northeast corner is repeatedly struck by oil and gas trucks making a westbound left from US 250 to SR 646. AutoTurn analysis confirms inadequate turn radii for trucks.

The existing intersection operates at an acceptable LOS, but geometric deficiencies exist including insufficient truck turn radii, substandard 11-ft. lane width on SR 646 and sight distance issues. Pavement widening at this location is desirable to improve turn radii, but is probably not feasible due to the directly adjacent Tappan Lake. Potential countermeasures should explore moving stop bars to facilitate truck turning movements and improved warning signage to mitigate sight distance issues.

Upgrading signage at this location entails replacing existing intersection warning signs with solar powered flashing LED lights. In addition, the warning sign on the eastbound approach should be relocated closer to the intersection in accordance with OMUTCD guidelines. Installing flashing beacons at the intersection is recommended if crash issues persist after upgrading signage.

Widening the existing intersection to improve the existing deficient turn radii, particularly at the northeast corner, would facilitate movements to and from SR 646, frequently traveled by oil and gas exploration freight, for a WB-62 truck without oversteering. Feasibility of this countermeasure is physically restricted by the adjacent Tappan Lake. Widening US 250 to install an eastbound left turn lane was considered, but pavement widths at the intersection are restricted by the adjacent Tappan Lake.

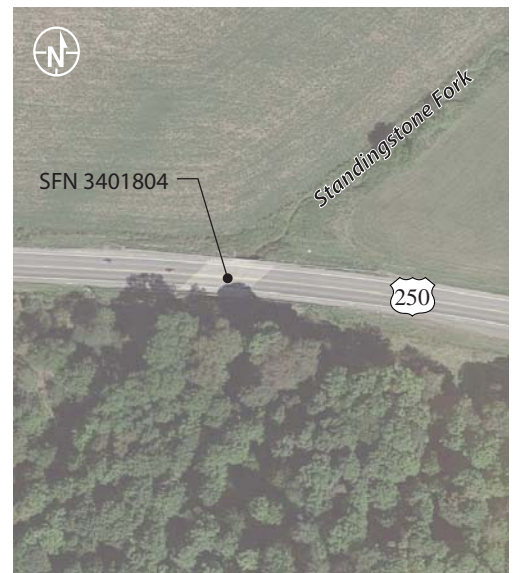
The structure has a General Appraisal of Seven indicating it is in Good Condition. The Load Rating for this structure is 150% of the Ohio Legal Load.

The existing structure has a substandard lateral clearance of six-ft. which poses a potential freight bottleneck for oversize loads. Potential countermeasures should explore reconstructing the existing structure to increase its lateral clearance to a standard eight-ft.

Deck	7
Superstructure	7
Substructure	7
Culverts	n/a
Channel	6
Approaches	8
<b>General Appraisal</b>	<b>7</b>

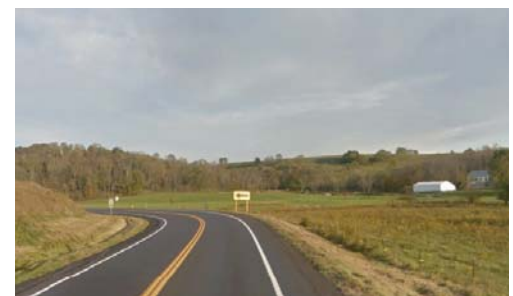
Crash analysis shows seven crashes observed along this segment during a three-year period (2012 to 2014) with six crashes citing a vehicle leaving the travel lane. Crash severity was high with two fatal crashes and one injury crash.

Crash severity at this location is high (two fatal crashes) and horizontal geometry is deficient for a 55 mph design speed. Potential countermeasures include additional warning signage in advance of and along this curve, the installation of rumble strips, and curve widening on this inside of this curve.

Looking EB along US 250 at sharp horizontal curve just west of the Harrison County Home.

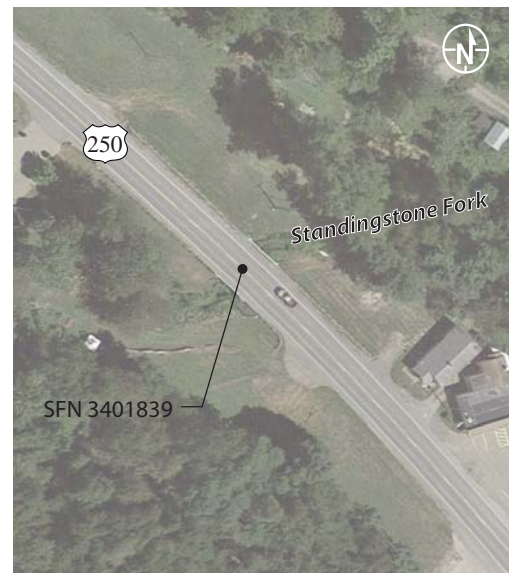
The structure has a General Appraisal of Seven indicating it is in Good Condition. The Load Rating for this structure is 150% of the Ohio Legal Load.

The existing structure has a substandard lateral clearance of 6.25 ft. which poses a potential freight bottleneck for oversize loads. Potential countermeasures should explore reconstructing the existing structure to increase its lateral clearance to a standard eight-ft.

Deck	7
Superstructure	7
Substructure	7
Culverts	n/a
Channel	6
Approaches	9
<b>General Appraisal</b>	<b>7</b>

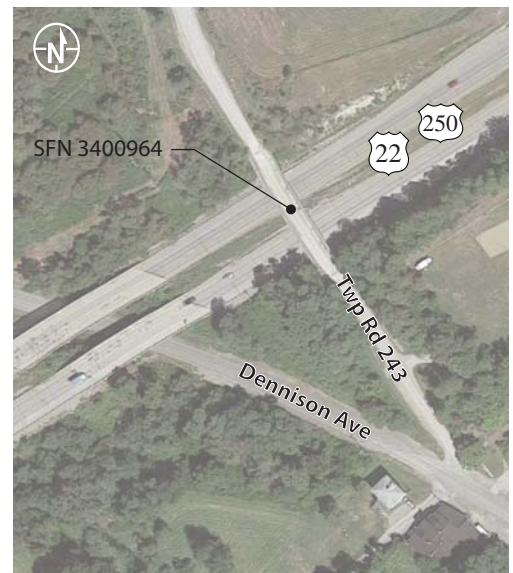
The structure has a General Appraisal of Four indicating it is in Poor Condition and Structurally Deficient. The deck and superstructure both have Summary Ratings of Four due to poor condition of the floor/sidewalks and rolled steel girders/protective coatings systems, respectively. The Load Rating for this structure is 150% of the Ohio Legal Load.

The existing structure is programmed to be permanently removed under PID 88923 in 2016. Township Road 243 access will be realigned to Dennison Avenue. No further countermeasures are recommended at this location.

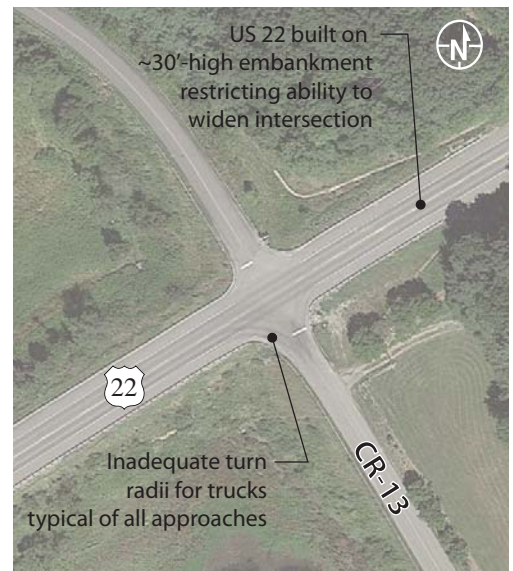
Crash analysis shows eight crashes observed at this intersection during a three-year period (2012 to 2014) with five rear end crashes, two sideswipe meeting, and one angle. Crash severity at this location was high with two fatal crashes and two injury crashes. Field observations showed trucks turning right from the CR 13 stop control approaches had to wait for traffic in both directions along US 22 to clear in order to complete a turning movement. AutoTurn analysis confirms inadequate turn radii for trucks.

The existing intersection operates at an unacceptable LOS in the 2040 PM peak hour and insufficient truck turn radii exist requiring right turning trucks from CR 13 to utilize both lanes on US 22 to complete a turn. Potential countermeasures to improve operation on the stop control approach are limited as improvements would degrade operation on the much higher volume US 22 approaches so rerouting local freight traffic to another access point along US 22 should be explored. If freight traffic cannot be rerouted, potential countermeasures at CR 13 should explore moving stop bars/pavement widening to facilitate truck turning movements.

Widening the existing intersection to improve the existing deficient turn radii, particularly at the southeast corner, would facilitate movements to and from CR 13, frequently traveled by oil and gas exploration freight, for a WB-62 truck without oversteering.
